NATIONAL PROGRAM FOR INSPECTION OF NON-FEDERAL DAMS
UPPER AMMONOOSUC DAM (U) CORPS OF ENGINEERS WALTHAM
MA NEW ENGLAND DIV AUG 81

UPPER AMMONOOSUC DAM
DOCUMENT IDENTIFICATION
AUG 1981

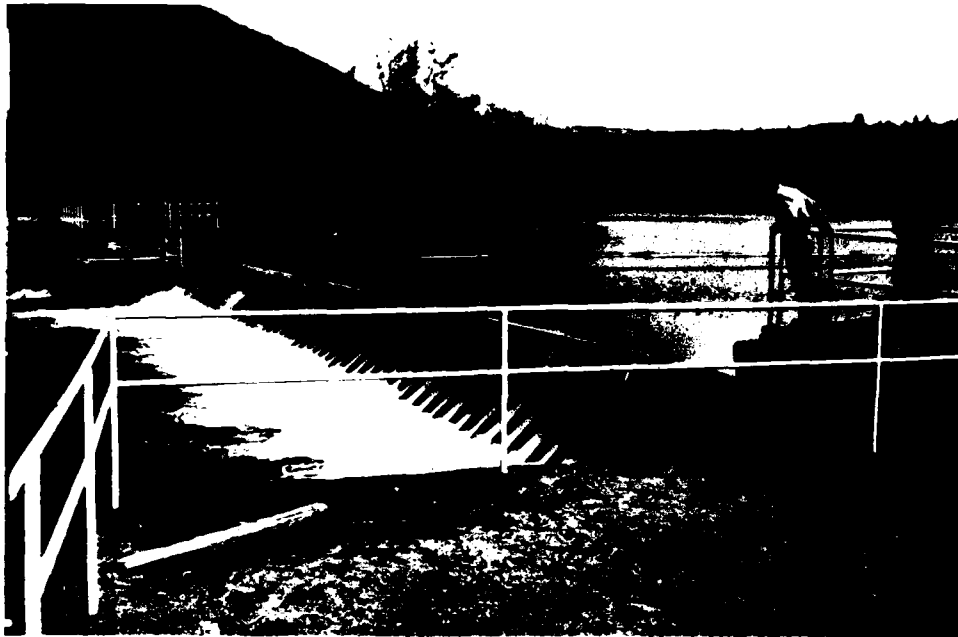
1. Spillway from Left Abutment
Note: Sink Hole at Lower Left

(b) Evaluate the condition of the timber crib and earthfill at the left abutment and prepare plans for its restoration.

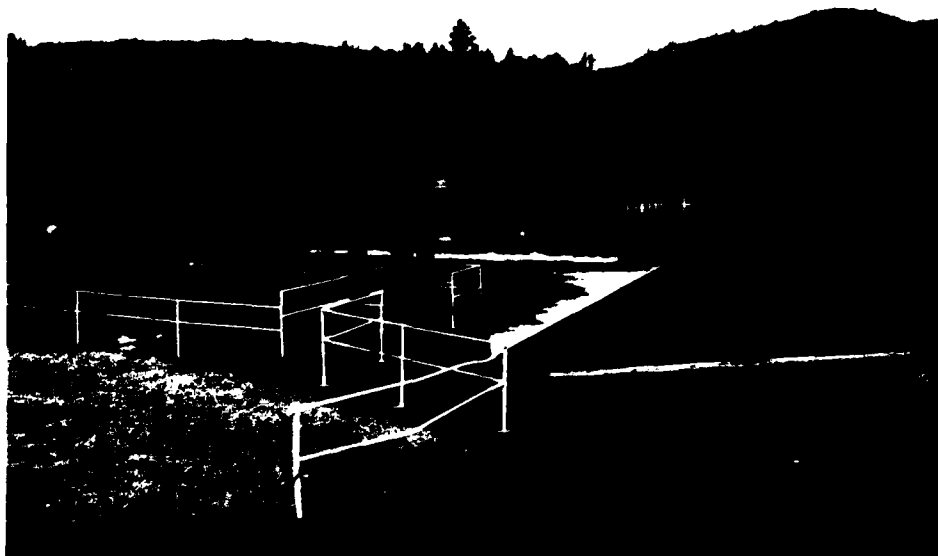
2. Overview from Upstream Left

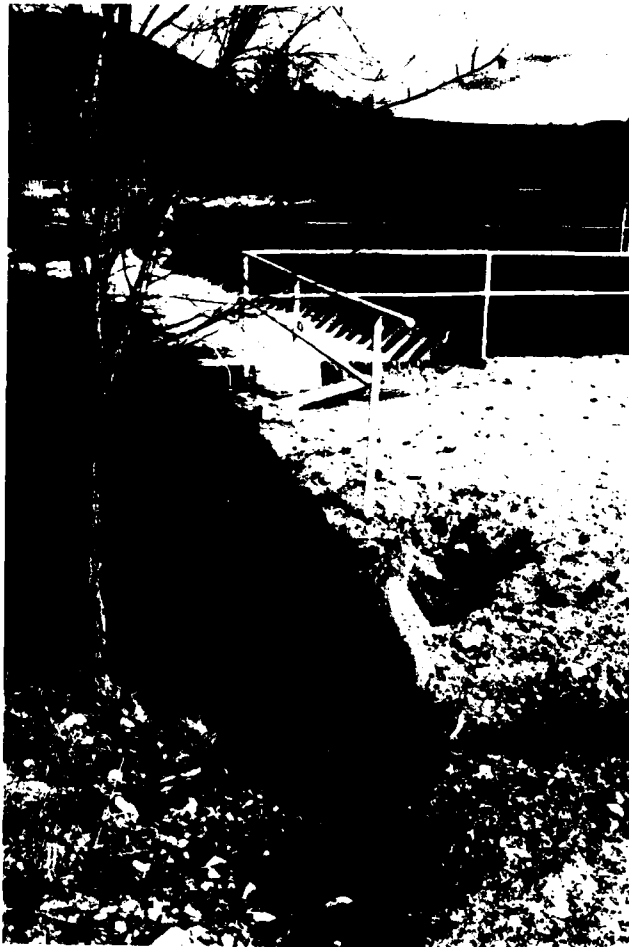
The Upper Ammonoosuc Dam is in fair condition at the present time. Evaluation of the decay of the left abutment is recommended. No other structural deficiencies were noted which warrant further investigation.

3. Sheeted Section at Left Abutment
Note: Sinkholes and Erosion

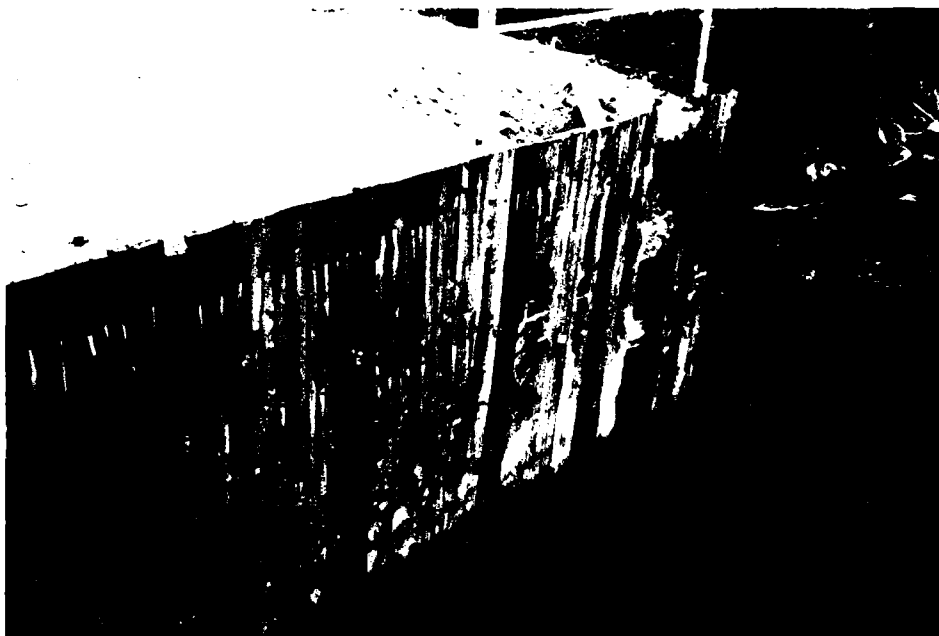
5. Missing Sheetting at Left Abutment

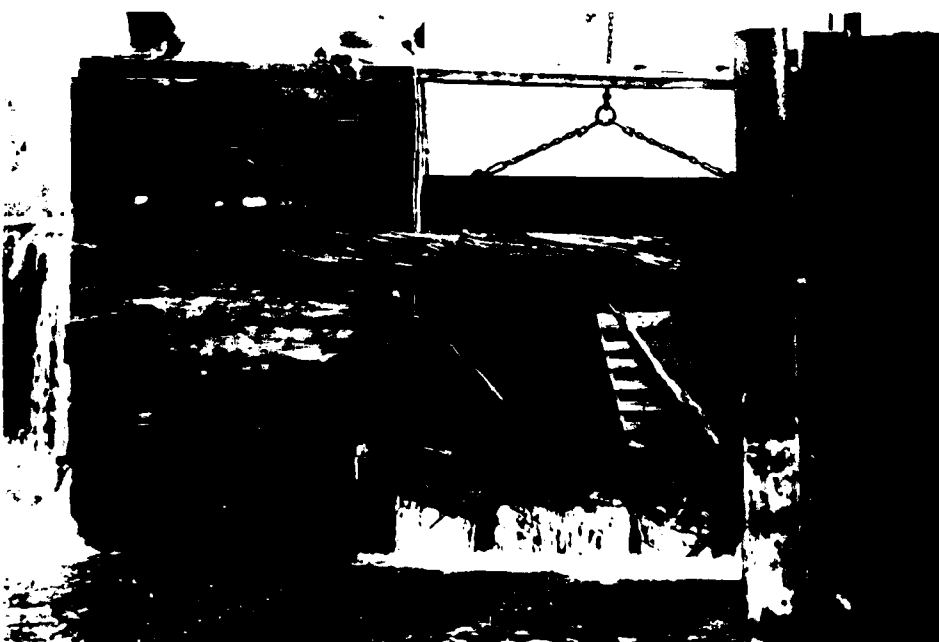
6. Downstream Side of Left Gate Structure
Note: Debris and Missing Sheetting

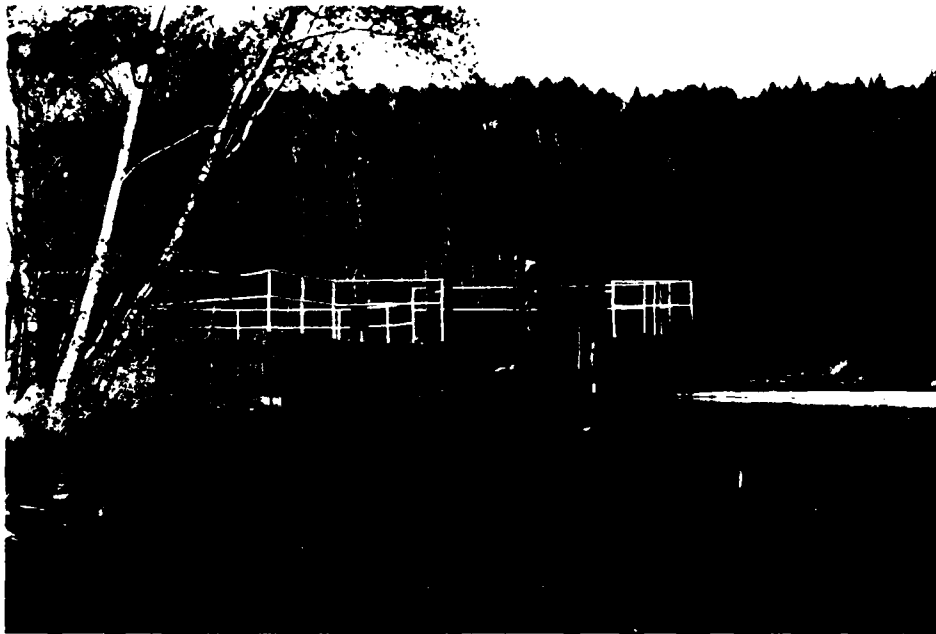
7. Upstream Side of Left Gate Structure

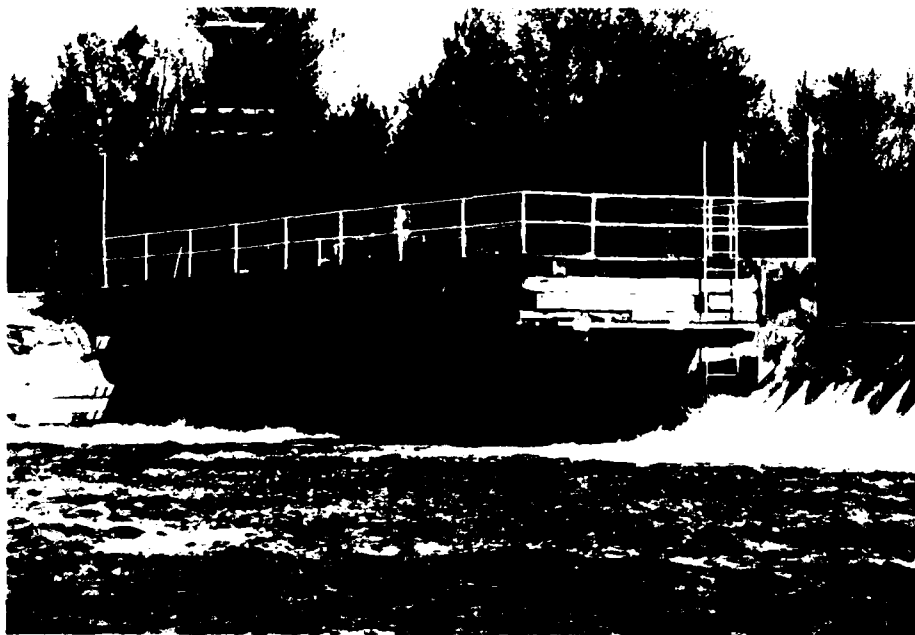
8. Downstream Side of Right Gate Structure

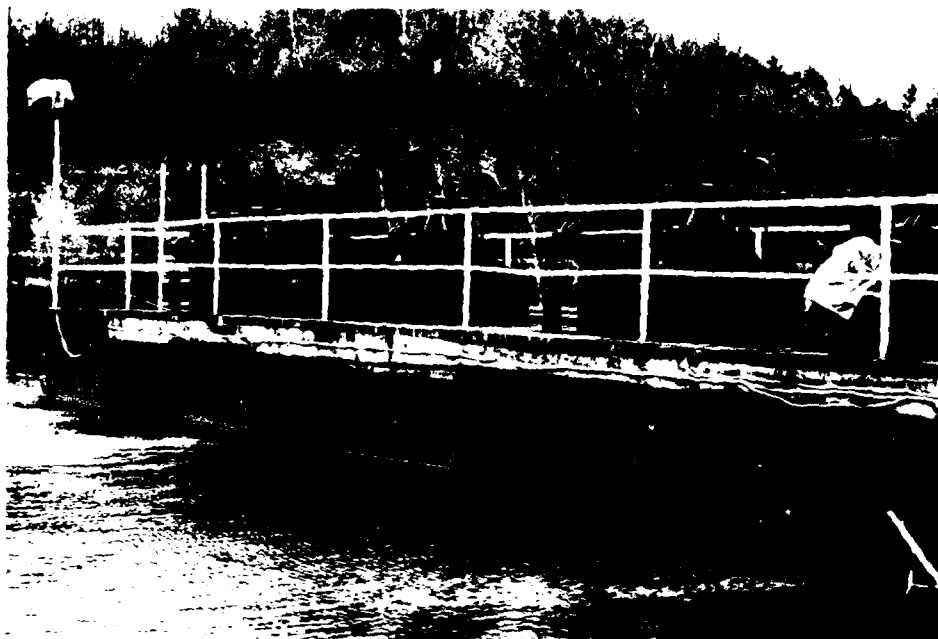
9. Upstream Side of Right Gate Structure

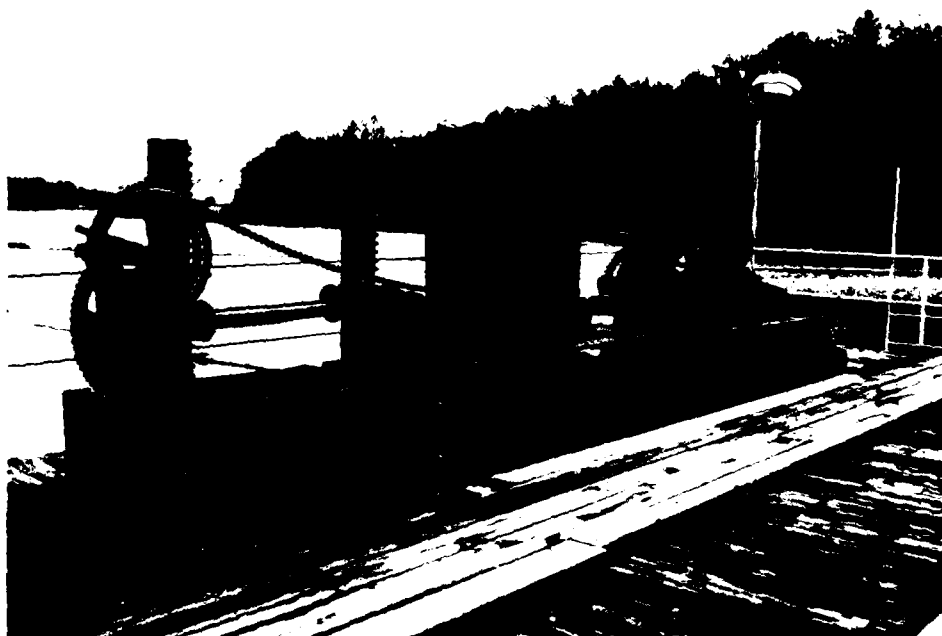
Two electric motors are installed to service two gates each. These motors can be attached by chain drive to provide assistance for lifting the gates. They appear to be in good condition.

10. Operating Mechanism at Right Gate Structure. Note: Box Houses Electric Motor
